**ABATTOIR (SLAUGHTERHOUSE) IN
QALADZE
SULAYMANIYAH, IRAQ**

**SIGIR PA-09-179
OCTOBER 16, 2009**

Summary of Report: PA-09-179

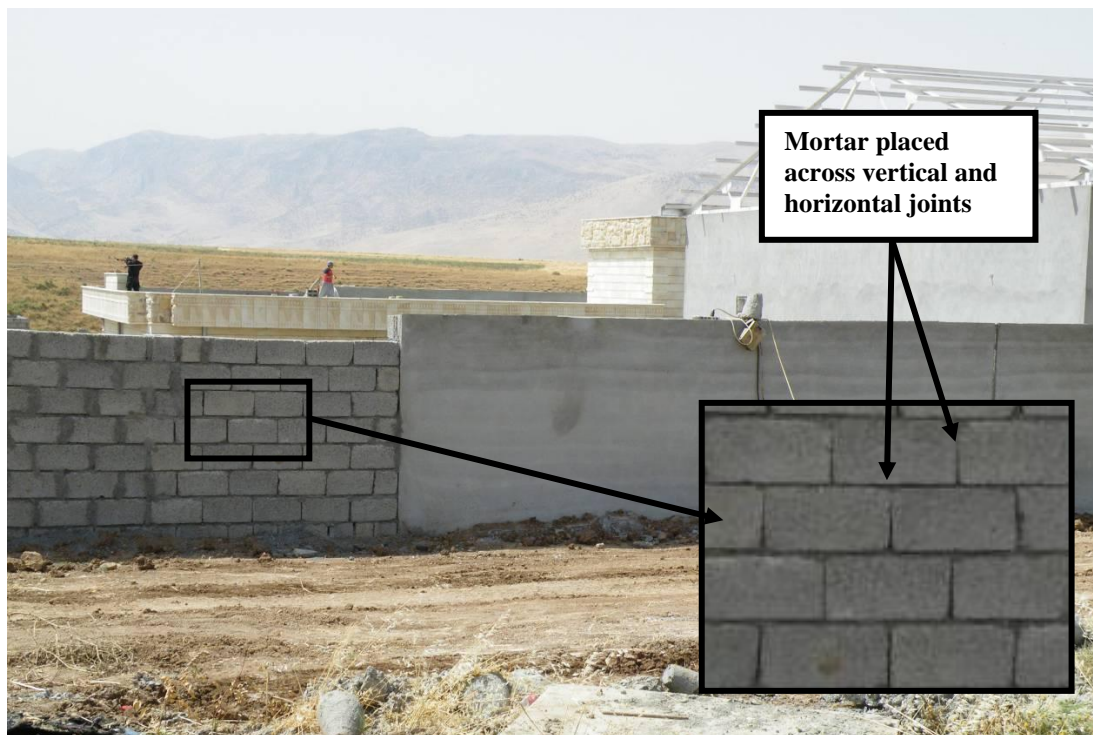
SIGIR inspected the partially completed security fence (Site Photo 5). The contractor had performed the required excavation work of backfilling and compaction prior to construction. The above-ground portion of the wall consisted of hollow concrete blocks with a cement plaster finish. The contractor fully bedded the joints between the concrete blocks for additional strength⁹. To complete the fence, the contractor must finish the cement plaster finish and install a metal door at the main gate.

Site Photo 5. Partially completed security fence surrounding the abattoir

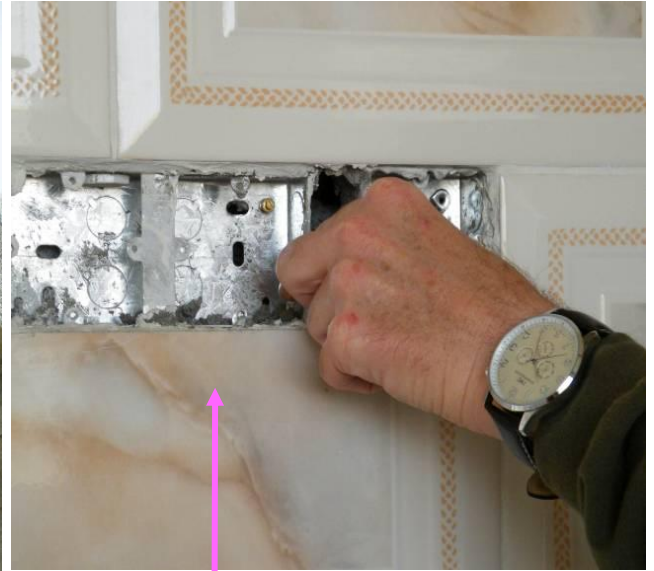
Site Photo 8. Preliminary electrical wiring

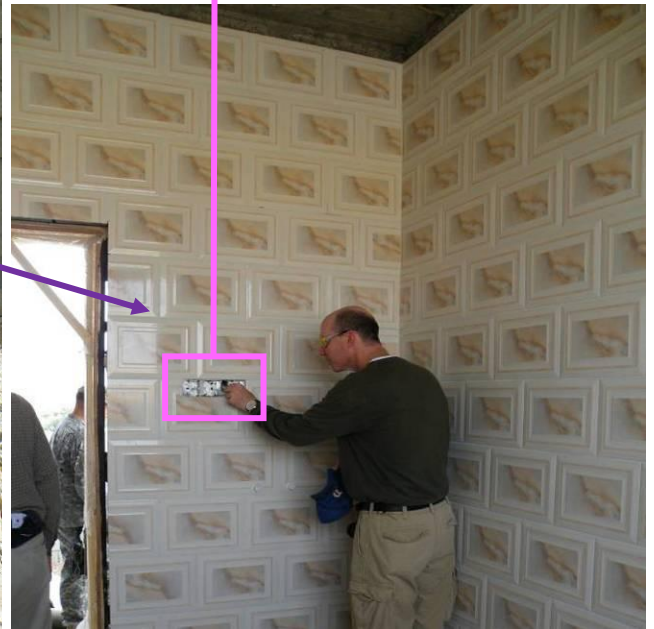
Site Photo 9. Glazed ceramic tiles on the interior walls

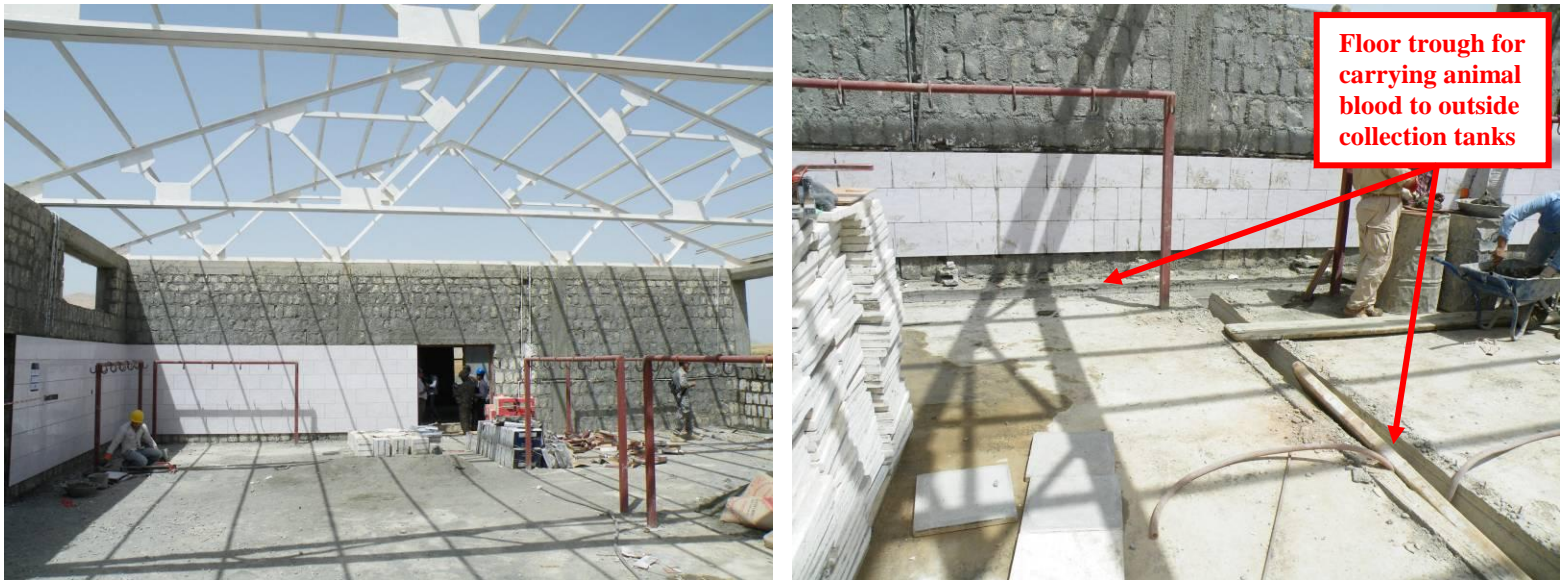
SIGIR inspected the open area slaughterhouse (Site Photos 10-11). The contractor had poured the concrete floor slab and placed the concrete block walls. The metal roof trusses and purlin (horizontal) supports had been welded together and were ready for the placement of the roof. SIGIR observed that the contractor did an above-average job welding the roof supports, which will provide additional strength for the roof. SIGIR noticed the floor trough/trench line in the middle of the facility, which will transport blood by gravity to the collection tanks outside the facility. The contractor had begun to install glazed ceramic tile along the walls, which is necessary for the abattoir workers to wash blood from the walls into the floor trough/trench line for proper disposal.

Site Photos 10 and 11. Interior views of the slaughterhouse room

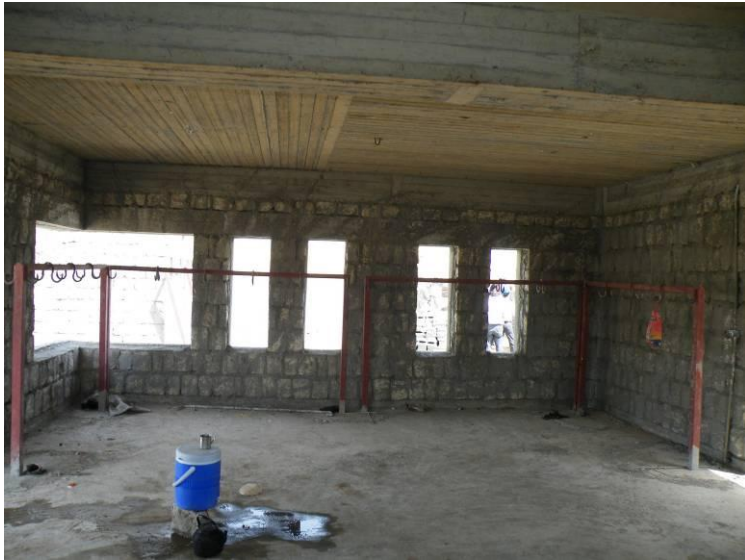
The contractor designed a 10 x 7 meter (m) single room for the winter hall. SIGIR inspected the partially completed winter hall (Site Photo 12). The contractor had poured the concrete floor and ceiling slabs and placed the concrete block walls. SIGIR observed good-quality concrete pours, which resulted in very little noticeable honeycombing or segregation. In addition, to provide additional support for the walls, the contractor buttered¹⁰ the joints between concrete blocks.

Site Photo 12. Interior view of winter hall

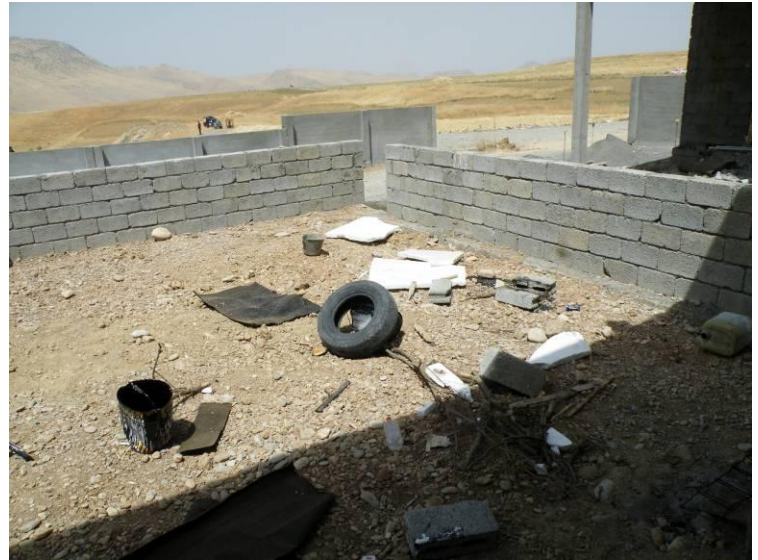
SIGIR inspected the outside summer hall, which the contractor designed as an enclosed area approximately 10.4m x 7m (Site Photo 13). The animal retaining wall was constructed of concrete blocks and appeared to be approximately 1m high. The summer hall provided some shade for the animals and also an open area to roam freely.

Site Photo 13. Exterior view of summer hall

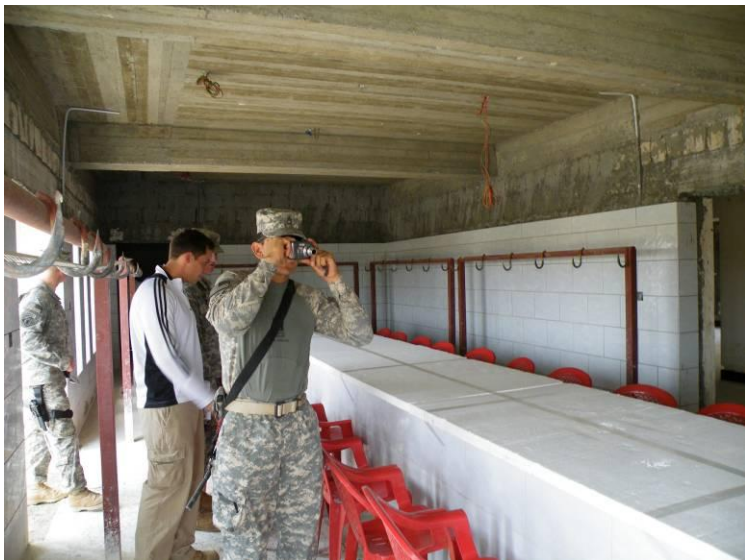
Site Photo 14. View of partially completed meat-testing hall

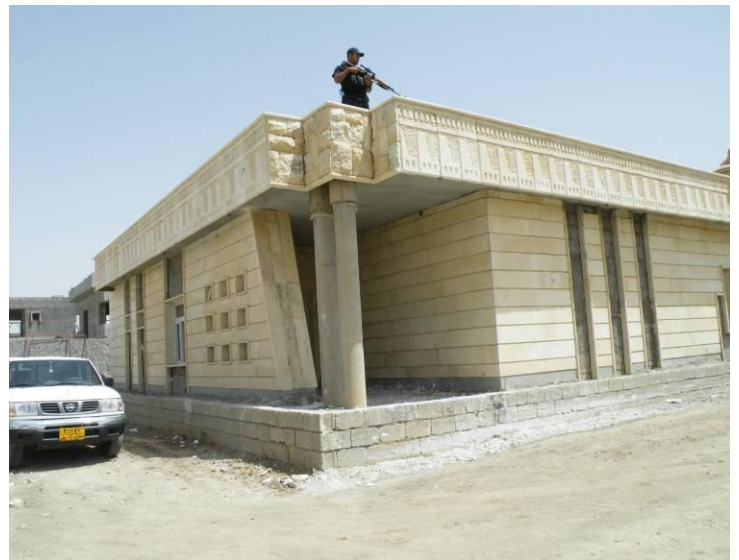
SIGIR observed good-quality concrete pours, which resulted in very little noticeable honeycombing or segregation. In addition, SIGIR noticed that the contractor used an elaborate and creative design for the exterior of this facility, using columns, unique geometric shapes, and stone-masonry facades (Site Photo 15). The facility has a distinctive exterior look.

Site Photo 15. Exterior view of meat-processing facility

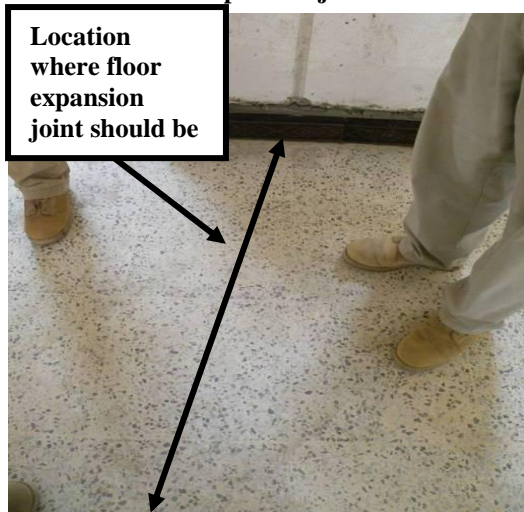
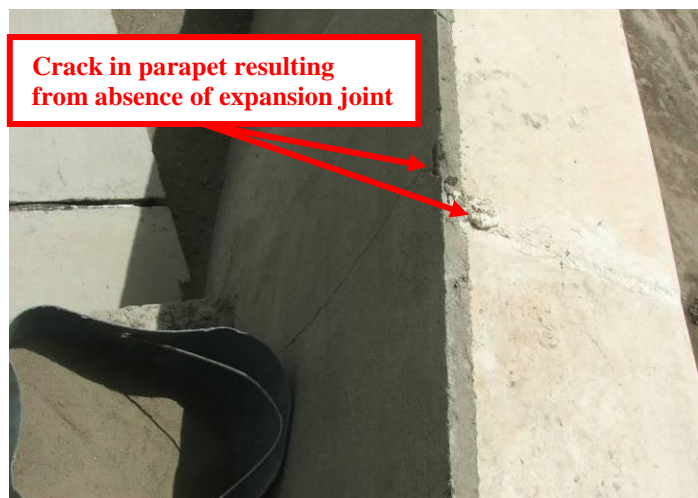
First, the facility's expansion joint system, which is to protect the structure from thermal variations, was incomplete. The expansion joint was correctly designed/placed for the ceiling beams, columns, walls, and roof slab; however, the joint was incorrectly finished and/or not finished at all for the floor and parapet (Site Photos 16-19). An expansion joint was designed and constructed for the wall columns; however, instead of placing the proper expansion joint material inside the joint, the contractor plastered inside it instead. The absence of an expansion joint for the parapet has resulted in a vertical crack. SIGIR found no expansion joint system for the facility's exterior walls. Considering that these walls are exposed to excessive heat in the summer and snow in the winter, a well-designed expansion joint system was warranted. Additionally, sealed joints prevent moisture, dust/dirt particles, and crawling insects from entering the living spaces. Consequently, an expansion joint system promotes structural safety for the building and also provides a better living environment for the occupants.

Site Photos 18 and 19. Absence of expansion joint for the floor (left) and parapet (right)

During the site visit, SIGIR identified these deficiencies to the KRO representatives. They readily agreed to the need for internal and external expansion joints and discussed the issue directly with the contractor's on-site representative. The contractor's representative agreed to provide a corrective action plan for the expansion joints to the KRO representatives.

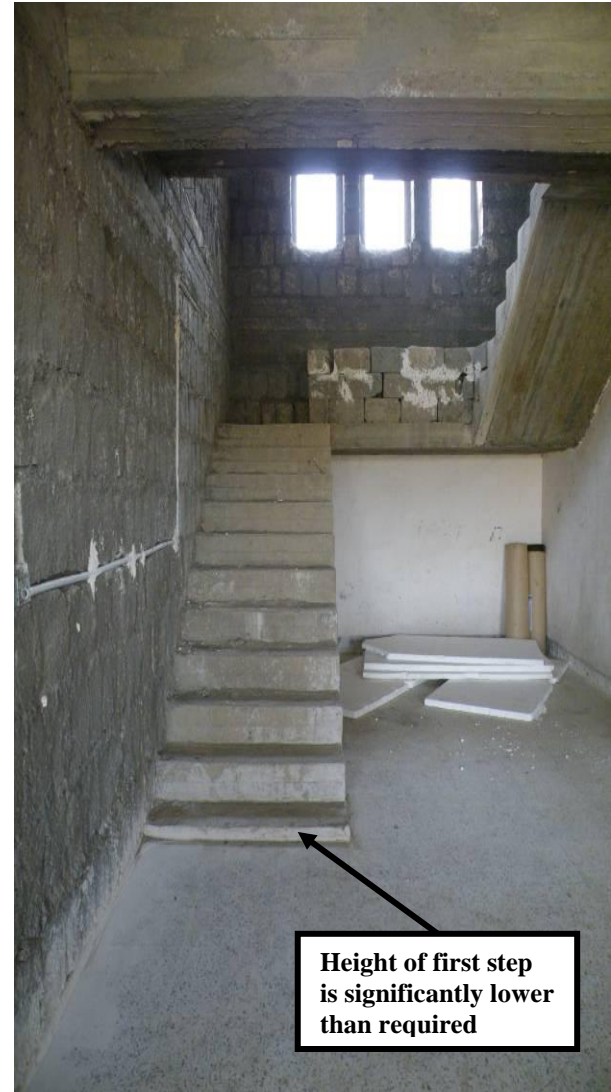
Second, SIGIR identified a tripping hazard inside the facility (Site Photo 20). The risers for a reinforced concrete stair unit are inconsistent and not within the dimensional range specified by the building code and detail shown on the design submittal (Figure 2). Specifically, the first step is only 7 centimeters high, instead of the required 17 centimeters. The site condition of the stair unit does not reflect the original design drawing. In order to provide a safe working environment, this tripping hazard needs to be corrected.

Site Photo 20. Bottom step poses tripping hazard

With regard to the tripping hazard, KRO representatives stated that a quality assurance (QA) daily report had previously identified this problem and that the KRO QA representative was working with the contractor on a corrective action plan.

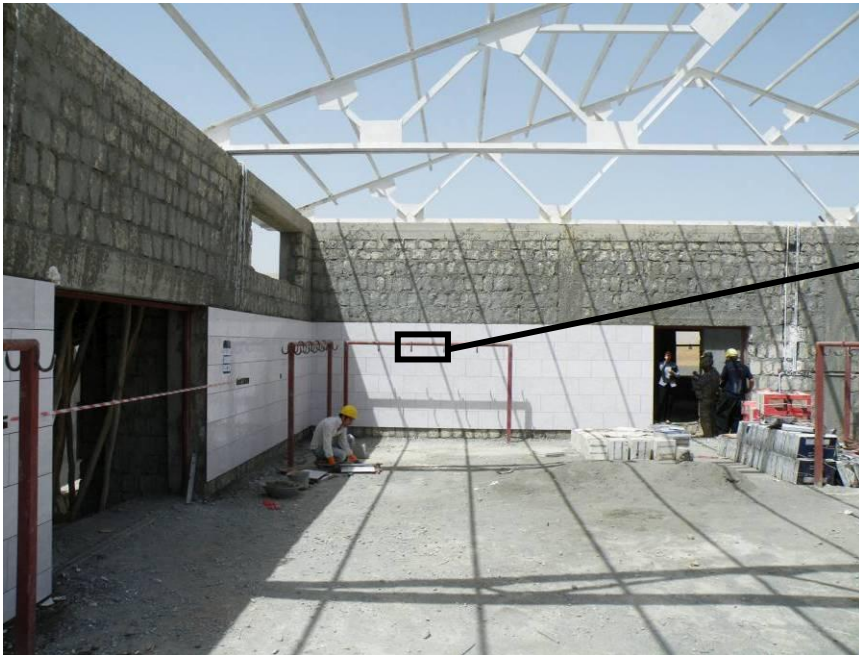
Finally, SIGIR noticed exposed meat-product support hooks throughout the entire abattoir—in the slaughterhouse, winter hall, and administration and meat processing facility (Site Photo 21). The very sharp tip of the exposed meat hook is approximately 5'7" above the ground (Site Photo 22). A typical construction area contains many tripping hazards, such as bags of materials, loose parts, and uneven flooring. It is a distinct possibility that a worker or visitor to the site may trip and fall into the meat hook. The meat hooks are essential to the production process for the facility; however, they also pose an extreme hazard for the workers.

Site Photo 21. Exposed meat support hooks located throughout facility

SIGIR pointed out this potential safety hazard to the KRO representatives, who agreed with the assessment and stated they would look into corrective action, such as covering the pointed ends with a suitable length of ½-inch diameter polyvinyl chloride pipe.
